POST-LAUNCH ANALYSIS

Abstract: Team Impulse produced a rover for the European CanSat competition which successfully recorded and sent back to the ground internal temperature, pressure and humidity. The altitude calculations based on pressure data were especially interesting, since they showed a reduction in descent speed which, it is suggested, was caused by the increase in air density on descent and thermals rising from the warm ground below. A brief description of the rover, both mechanically and electronically, is given, along with the lessons learnt from the project in terms of mechanical and electronic design. The rover, although it was not demonstrated immediately after launch, was tested and demonstrated to the judges the day after launch; the circumstances contributing to this failure are described.

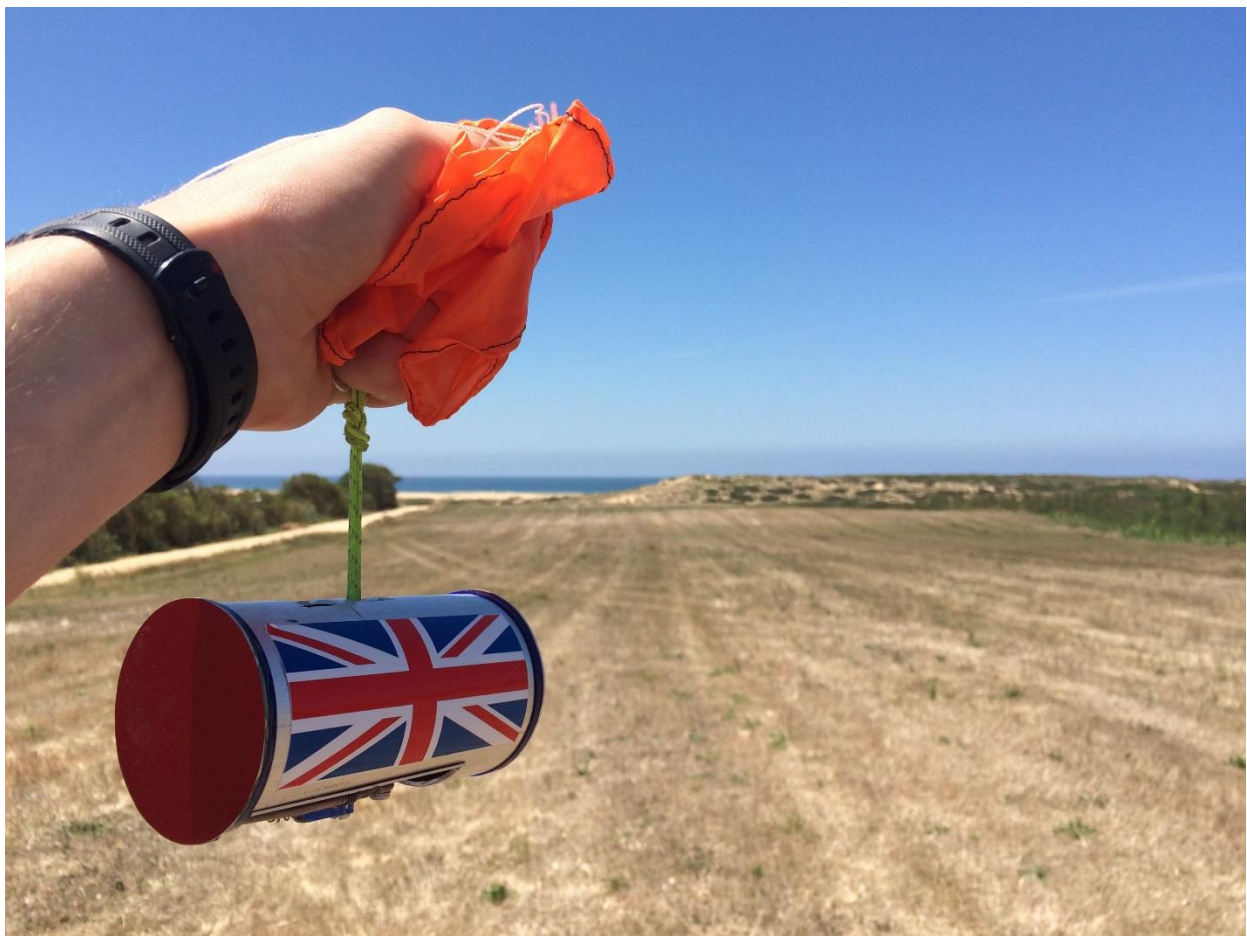
Figure 1--CanSat before launch

back-plate to ensure that the impact of landing would not shatter them. Figure 1 shows a photograph of the rover, with the parachute attached, shortly before launch. To improve repeatability and reliability, the design was produced using CAD software; Figure 2 shows the CAD model.

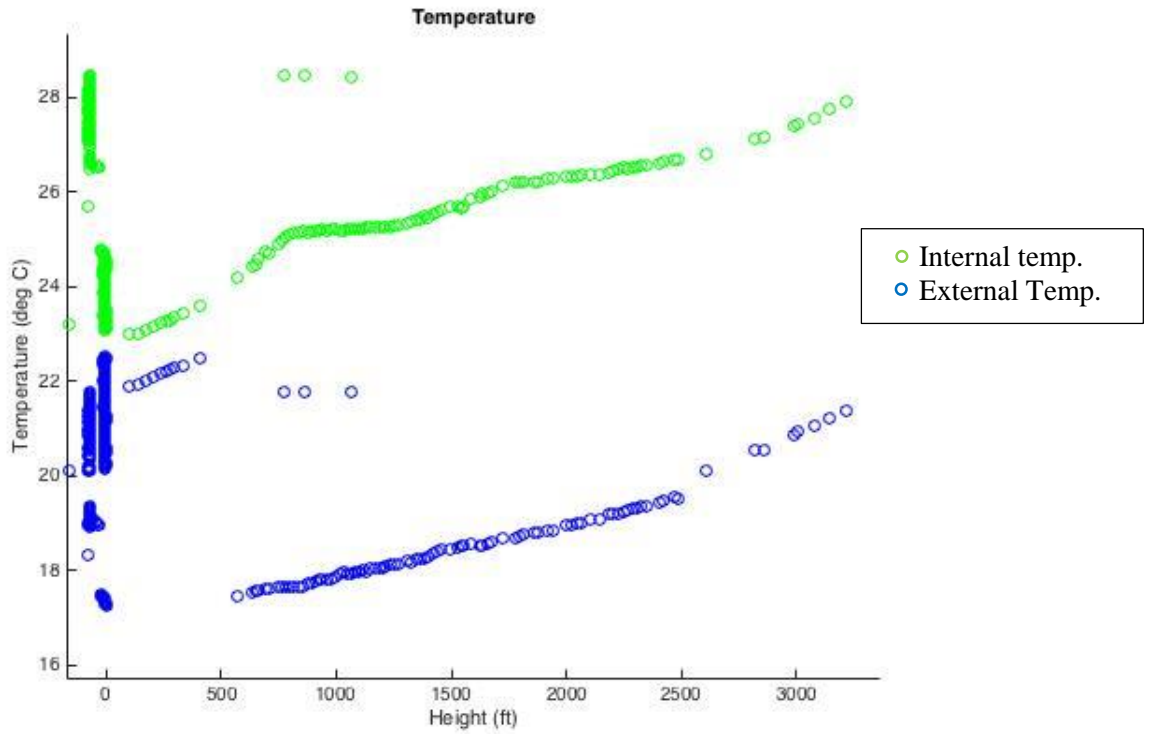
Figure 3 - Temperature graph

The temperature graph (Fig 3) shows internal and external temperature. The internal temperature is shown in green, and is markedly warmer than the external temperature; this is due to the different placement of the sensors. The internal temperature sensor is on the main PCB, and so allows measurement of the heat produced by the electronics. The external temperature probe is mounted just inside an aperture in the can which allows air circulation. There was a temperature inversion in effect on the day of the launch (as confirmed by airport staff) which was responsible for the increase in temperature with altitude (rather than the decrease one would expect). There is a distinct correlation between the graphs, however; this indicates that the external temperature sensor was not completely in equilibrium with the outside air; a possible improvement would be to have the sensor protruding from the can entirely. The three anomalous points between 500 and 1,000 feet are likely data points collected during the ascent of the can—there were very few of these since a data rate of around 1Hz was used and the rocket's ascent took less than 10s. They may be explained either by the propagation of heat from the rocket motor upwards (considered relatively unlikely) or the effect of a lack of air circulation on the contents of the rocket, with electronics heating. The alternative explanation is an error in data transmission, but this is considered unlikely due to the mode of action of the LoRa modem. Overall, though, the temperature measurement may be considered a success.

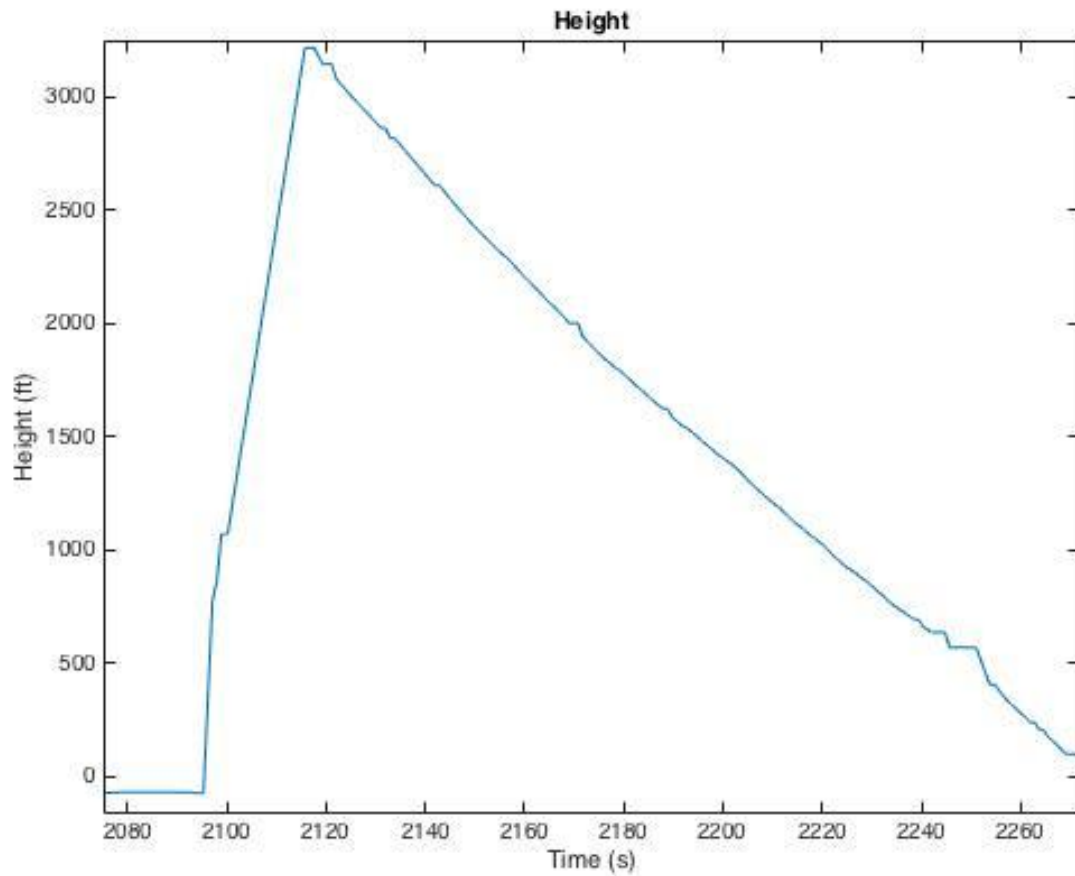
Figure 8 - Height graph

The graph of altitude with time is much as one would expect; the initial ascent is completed in approximately 20 seconds to an apogee of 3290 ft above the ground. This is followed by a slower-than-expected descent, at approximately 6m/s, to the ground. This is within the 20% tolerance applied to the competition descent rate requirements and so may be considered successful.

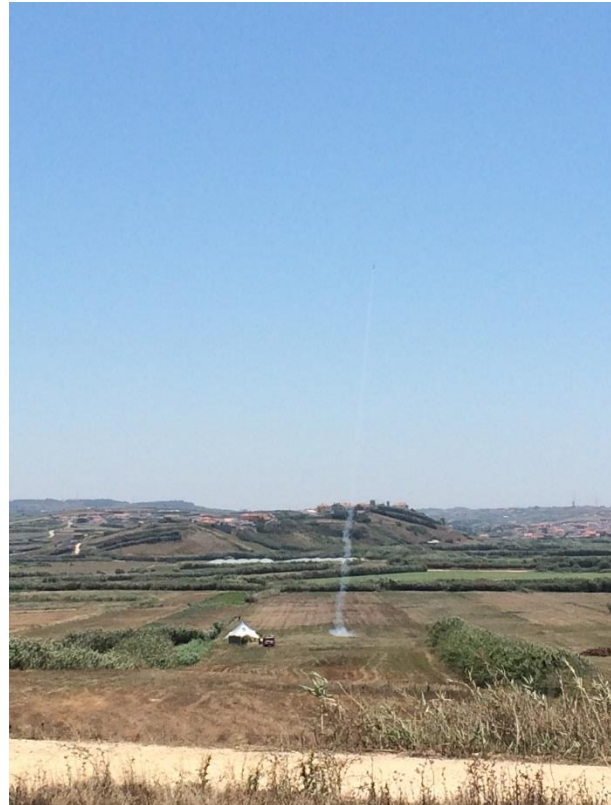
Figure 9 - Weather on launch day

The dew point, as calculated in equation [1], shows a heavy correlation with humidity, as would be expected; the high level of variance leads to the conclusion that dew point measured at ground level may not always be accurate at altitude. This presents hazards for pilots, especially of light aircraft—icing of wings, propellers, and, in the case of aircraft of older design (including most of the current light aircraft fleet), carburettor icing. The calculated dew point remained significantly below the measured air temperature at all times, which would agree with the fact that no cloud cover was observable on the day of launch over the launch site (see Fig 9). The dew point calculation, notwithstanding the slight
